# Manhole Inspection Summary

Manhole # S13GG2020MH

**Location** Address: **5913 EASTCLIFF DR**

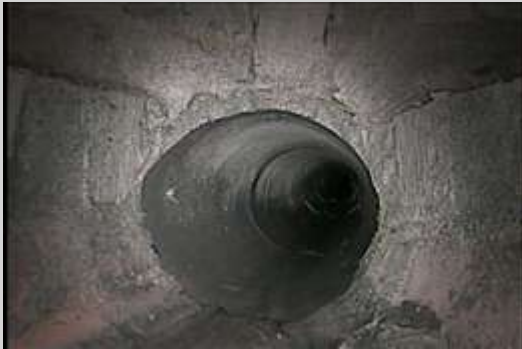
### 8 in. Circular Gravity Sewer Pipe Out @ 12 O'Clock

Pipe Material: **Clay** ☐ Pipe Lined

Infiltration: **None** Pipe Seal Cond: **Unknown**
